I&I study reveals several issues with Sudbury's wastewater collection system

The City engaged R.V. Anderson Associates Ltd. (RVA) to complete an inflow and infiltration (I&I) study on the wastewater collection system in Lo-Ellen Park, which is a primarily residential area in the

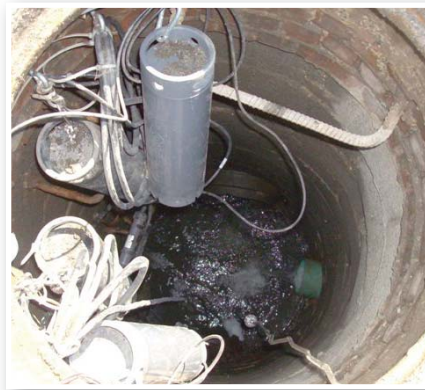
Sigma flow monitors and Telog recording telemetry units during study.

Flow monitors were equipped with remote communications by means of Telog RU-33 recording telemetry units. These units were directly connected to the Sigma flow monitors, and logged data as it was being collected. The telemetry units would call the Internet service provider at regular 12-hour intervals, via mobile telephone service, and report the data recorded.

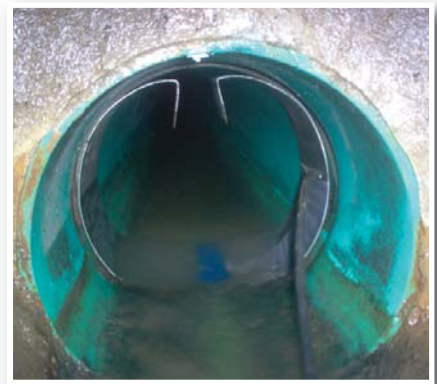
Probe and band in sewer.

monitors and submerged area/velocity sensors were used to monitor sewage flows. The monitors were installed in March 2009 and removed from service in early February 2010. During the course of the study, the City commissioned a permanent flow meter, hence one of the portable meters was relocated in order to measure flows in another region of the study area. Also, a portable American Sigma data-logging rain gauge was set up in a central location to collect rainfall data for the study area. Flow monitor and rain gauge data was recorded at 15-minute intervals.

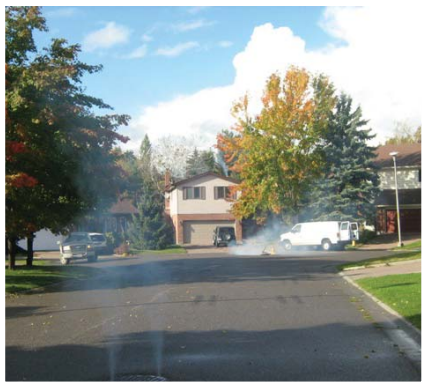
In addition to the flow and rain monitoring, smoke testing was carried out on roughly 20 km of sewer and service laterals of the Lo-Ellen Park area. This testing involves forcing vaporized liquid smoke into the sanitary sewer system with a portable high-powered fan. The objective of this portion of the investigation was to confirm sewer configuration and identify I&I sources, as flow monitoring alone does not provide a complete picture.

Typically, smoke is visible as it emits from all openings into the sanitary sewer system, such as roof vents and maintenance holes. However, occasionally smoke is visible coming from points where the sanitary system should not be connected — such as roof downspouts or storm sewer catch basins.

A media release was first issued to residents advising them of the planned work, and a public open house was hosted by the City to answer questions. Testing was carried out over a five-day period in October 2009. In general, results of the smoke testing indicated there were no combined sewer, roof leader or foundation drain connections. The testing did provide information on one possible “indirect” connection, open cleanouts in lawns and possible sags in the sewer system. Five maintenance holes were identified as possible heavy water inflow sources.

Smoke testing was carried out on roughly 20 km of sewer and service laterals of the Lo-Ellen Park area.

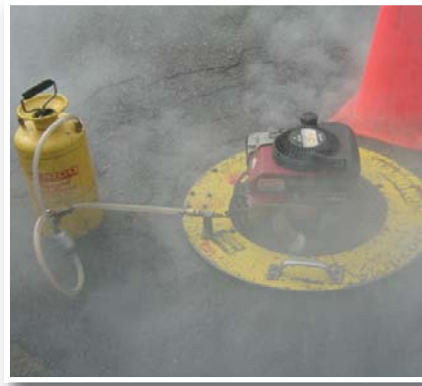
Smoke machine.
